Channel Change on the Santa Cruz River, Pima County, Arizona, 1936–86

By JOHN T.C. PARKER

U.S. GEOLOGICAL SURVEY
Open-File Report 93—41

Prepared in cooperation with the
PIMA COUNTY DEPARTMENT OF TRANSPORTATION
AND FLOOD CONTROL DISTRICT

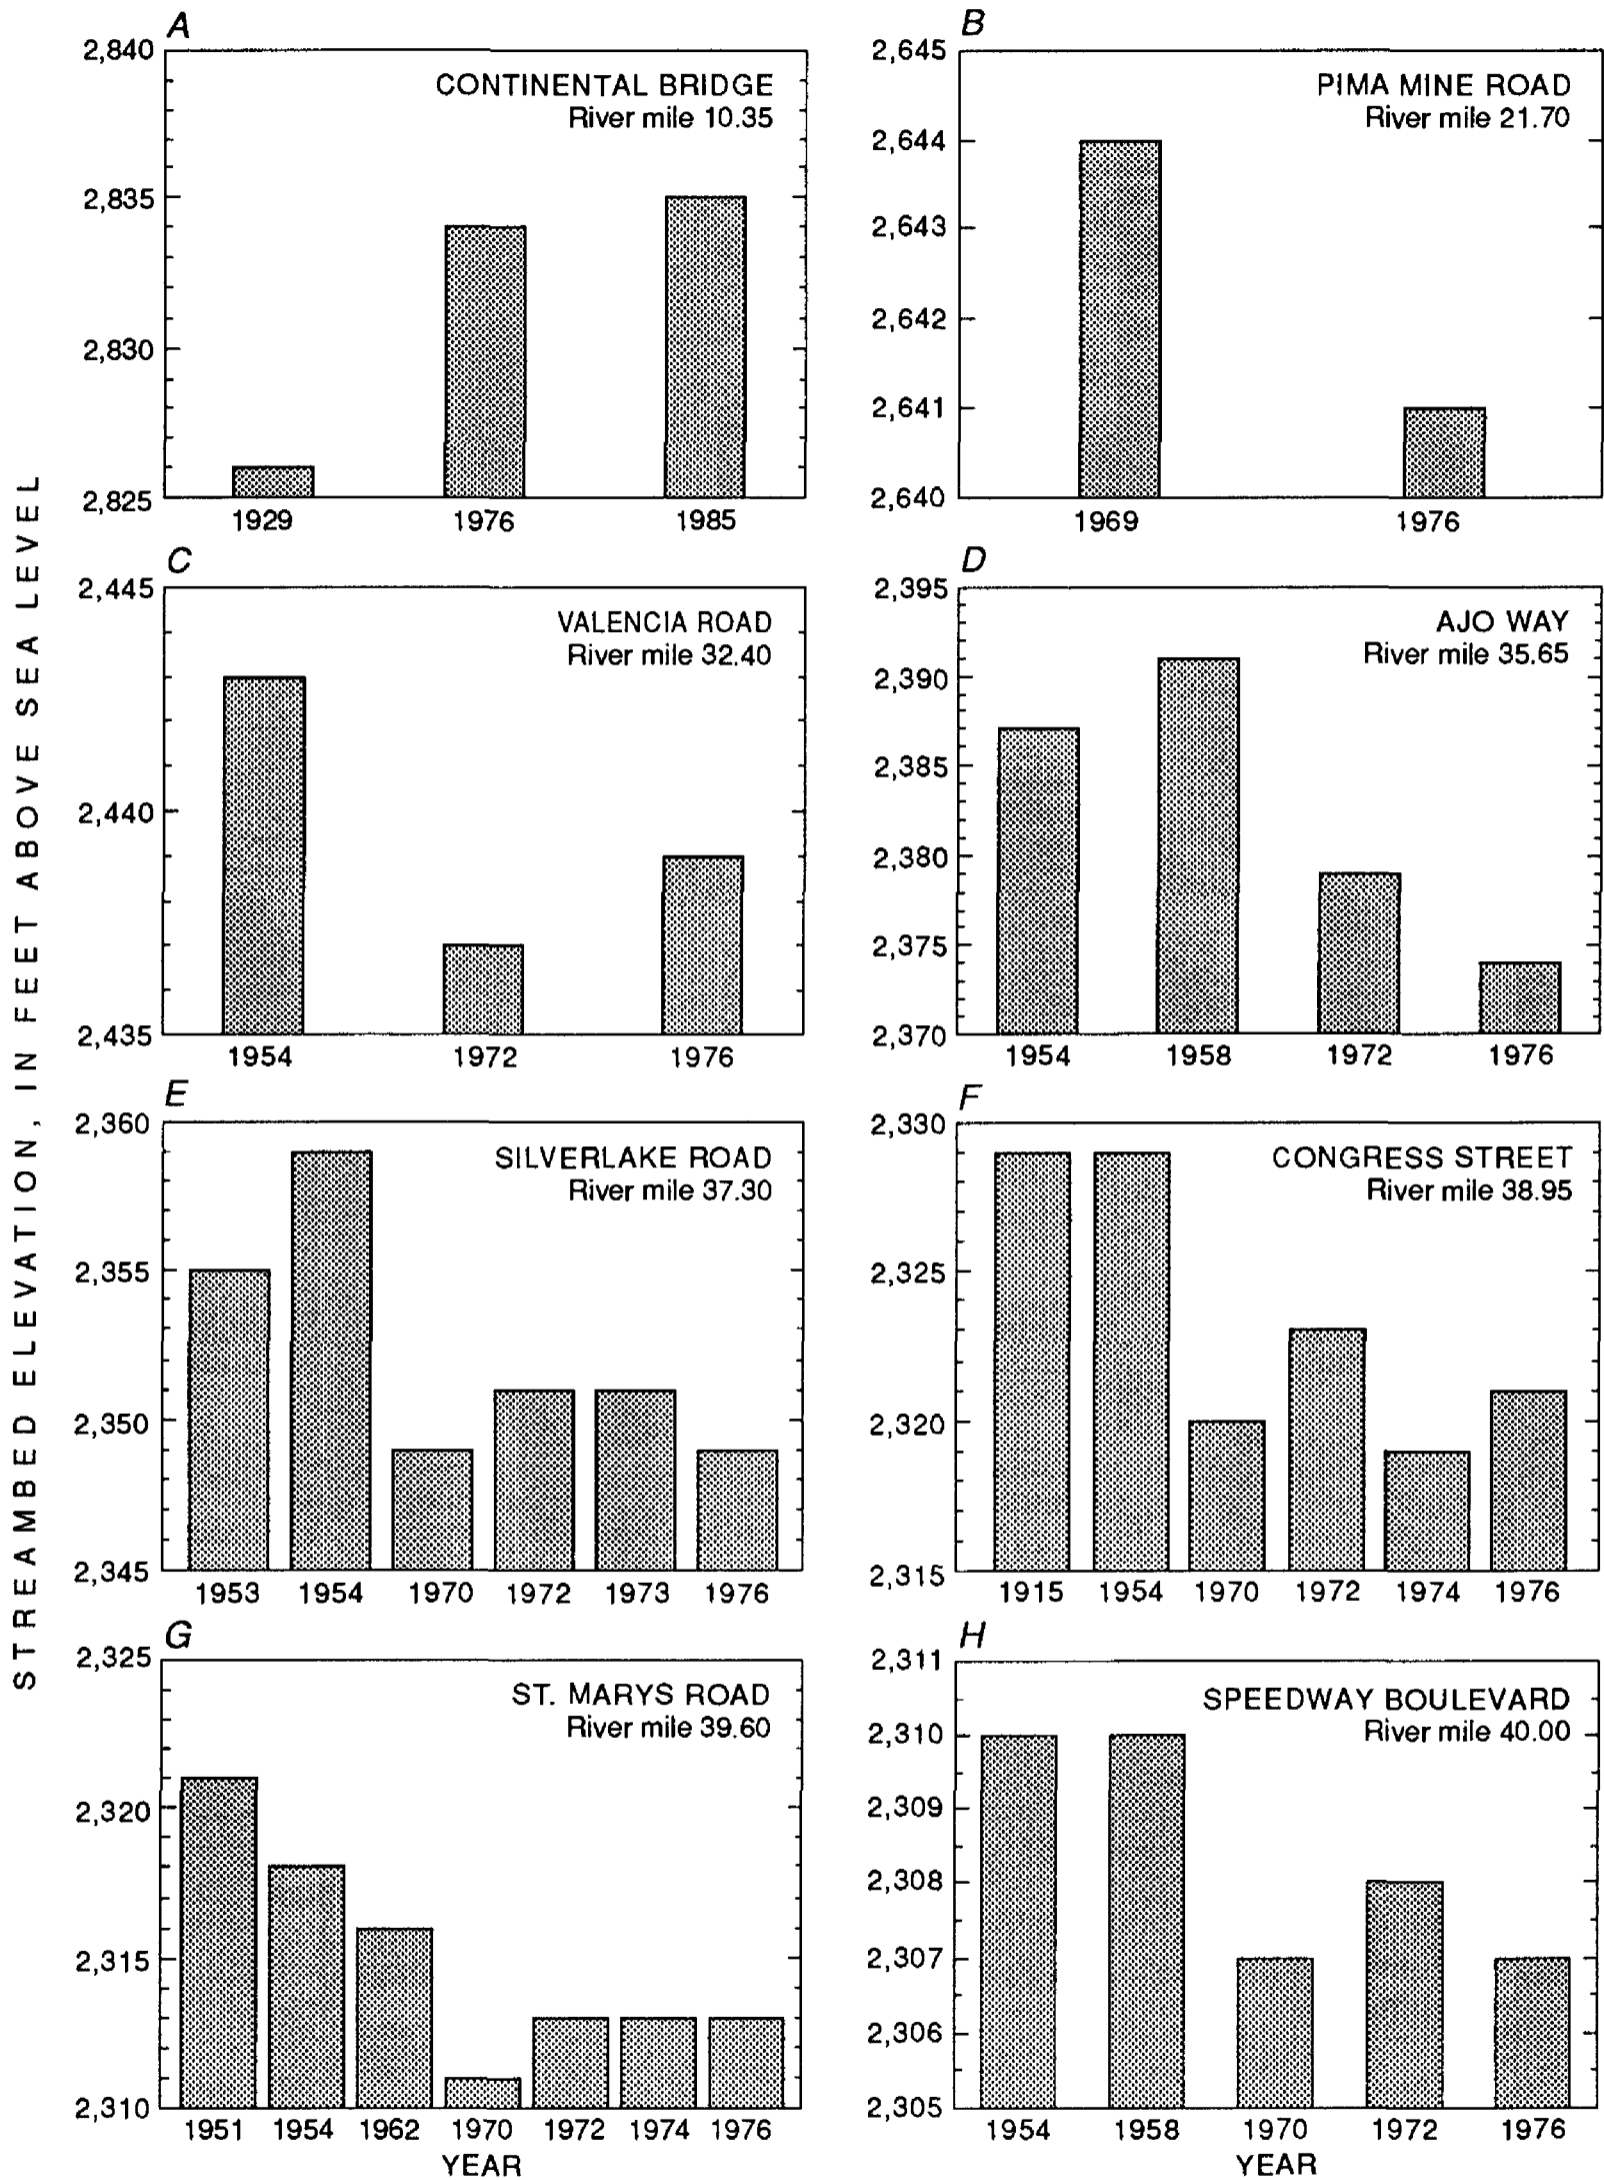
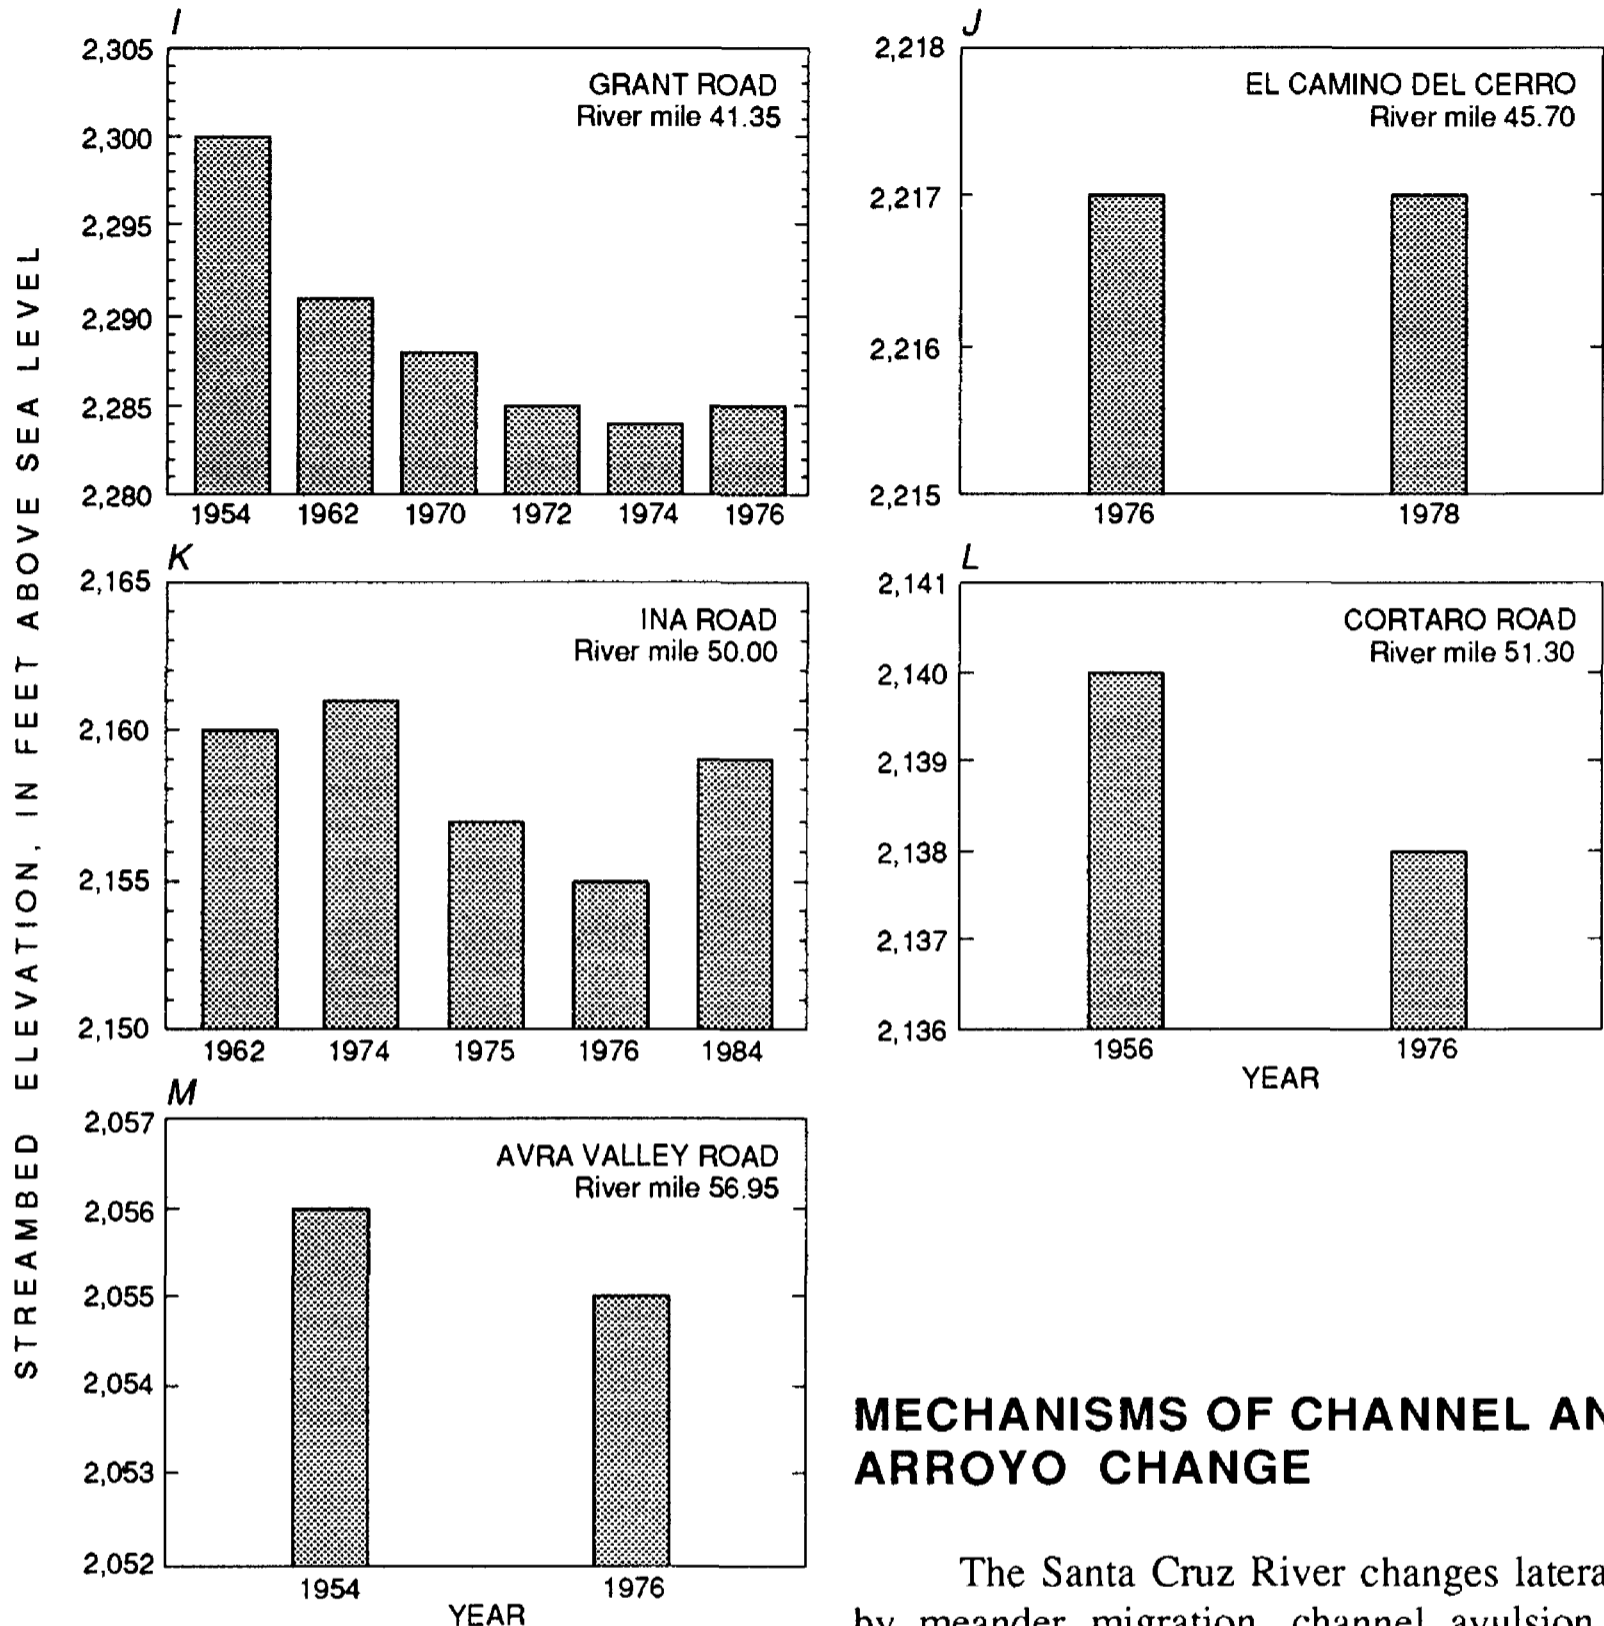
Figure 5. Changes in streambed elevations, Santa Cruz River. Note the vertical scale changes among various graphs. (Source: Data from Federal Emergency Management Agency, 1982, 1987, 1990; Pima County Department of Transportation and Flood Control District.)

From 1936 through 1986, channel change on the Santa Cruz River was characterized by an increase in width and a decrease in length throughout most of the study area (table 1 and fig. 4). Most of the reduction in length was the result of channelization. The increase in mean width would have been greater except for human intervention such as bank armoring, which inhibited channel widening, and landfill operations or channel maintenance, which narrowed channels artificially. Net vertical change in the same period was primarily degradational (fig. 5).

The Tucson reach has shown the least lateral instability during the study period (fig. 4D). Much of the apparent stability is artificial—either as a result of bank armoring, which has prevented channel change, or of artificial filling, which has obscured the record of change occurring between 1936 and 1986. Parts of the reach underwent about 15 ft of degradation between the 1950's and 1976 (fig. 5J).

Incision was apparently underway by 1962 (fig. 5G and I), and maximum degradation had occurred at most sites between Valencia and Grant Roads by 1970-74. Following maximum incision, minor fluctuations in streambed elevation occurred through the 1970's.

and Avra Valley Roads between the 1950's and 1976; however, a more complete record at Ina Road (fig. 5K) suggests that this interval was characterized by fluctuating streambed elevations. The period of maximum degradation in the mid-1970's lagged slightly behind upstream degradation. Aggradation of 4 ft at Ina Road during the flood of 1983 (fig. 5K) occurred in conjunction with extensive lateral shifts in channel position by avulsion and meander cutoff.

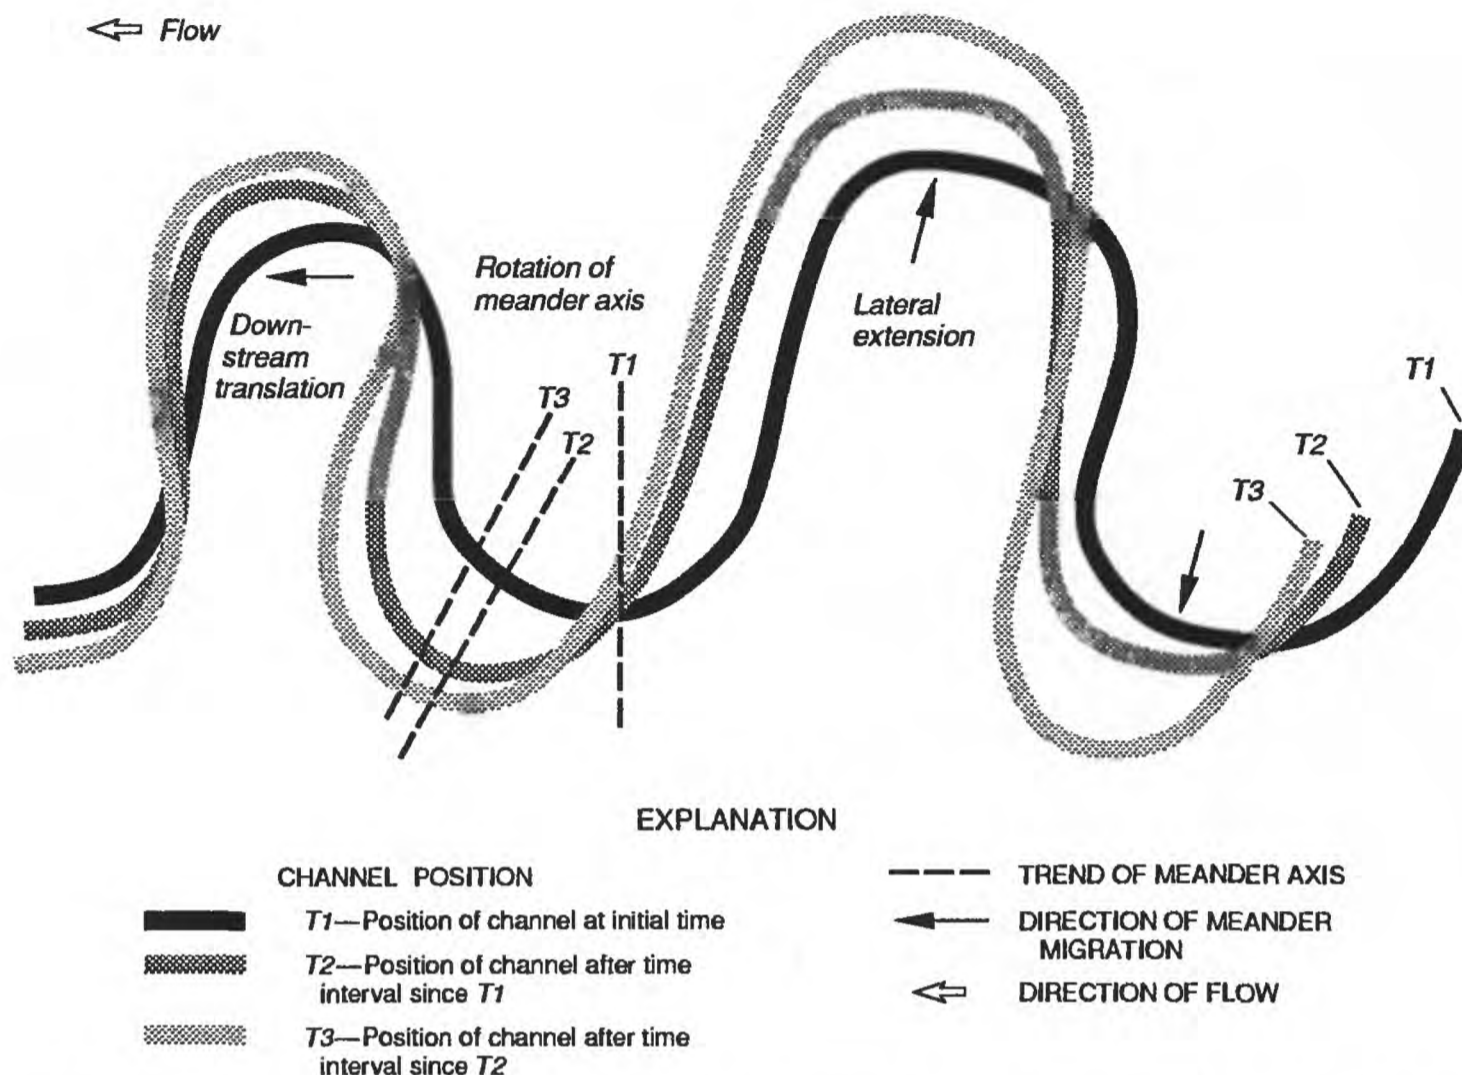
Figure 6. Channel migration caused by downstream translation of meander rotation of meander axis, and lateral extension of meander. Positive values indicate shift in position toward left side of channel; negative values indicate shift toward right side.

Meander migration refers to lateral shifts of center-line position associated with the inception of meanders and their subsequent downstream translation, lateral extension, or rotation of meander axis (fig. 6; Knighton, 1984). Meander migration involves the spatially continuous movement of channel position across a flood plain rather than a discrete, abrupt channel shift caused by avulsion or meander cutoff. Generally, meander migration increases sinuosity and lowers gradients. Where the channel is not confined within an arroyo, meander migration may be the dominant expression of lateral instability. Where the channel is confined within an arroyo, meander migration is a major component of arroyo widening. Meander migration on the Cortaro and Marana reaches is primarily a result of low to moderate flows that generally produce low rates of lateral channel movement. Moderate but prolonged flows having a peak discharge with a recurrence interval of 2 years or less, however, have caused hundreds of feet of erosion by meander

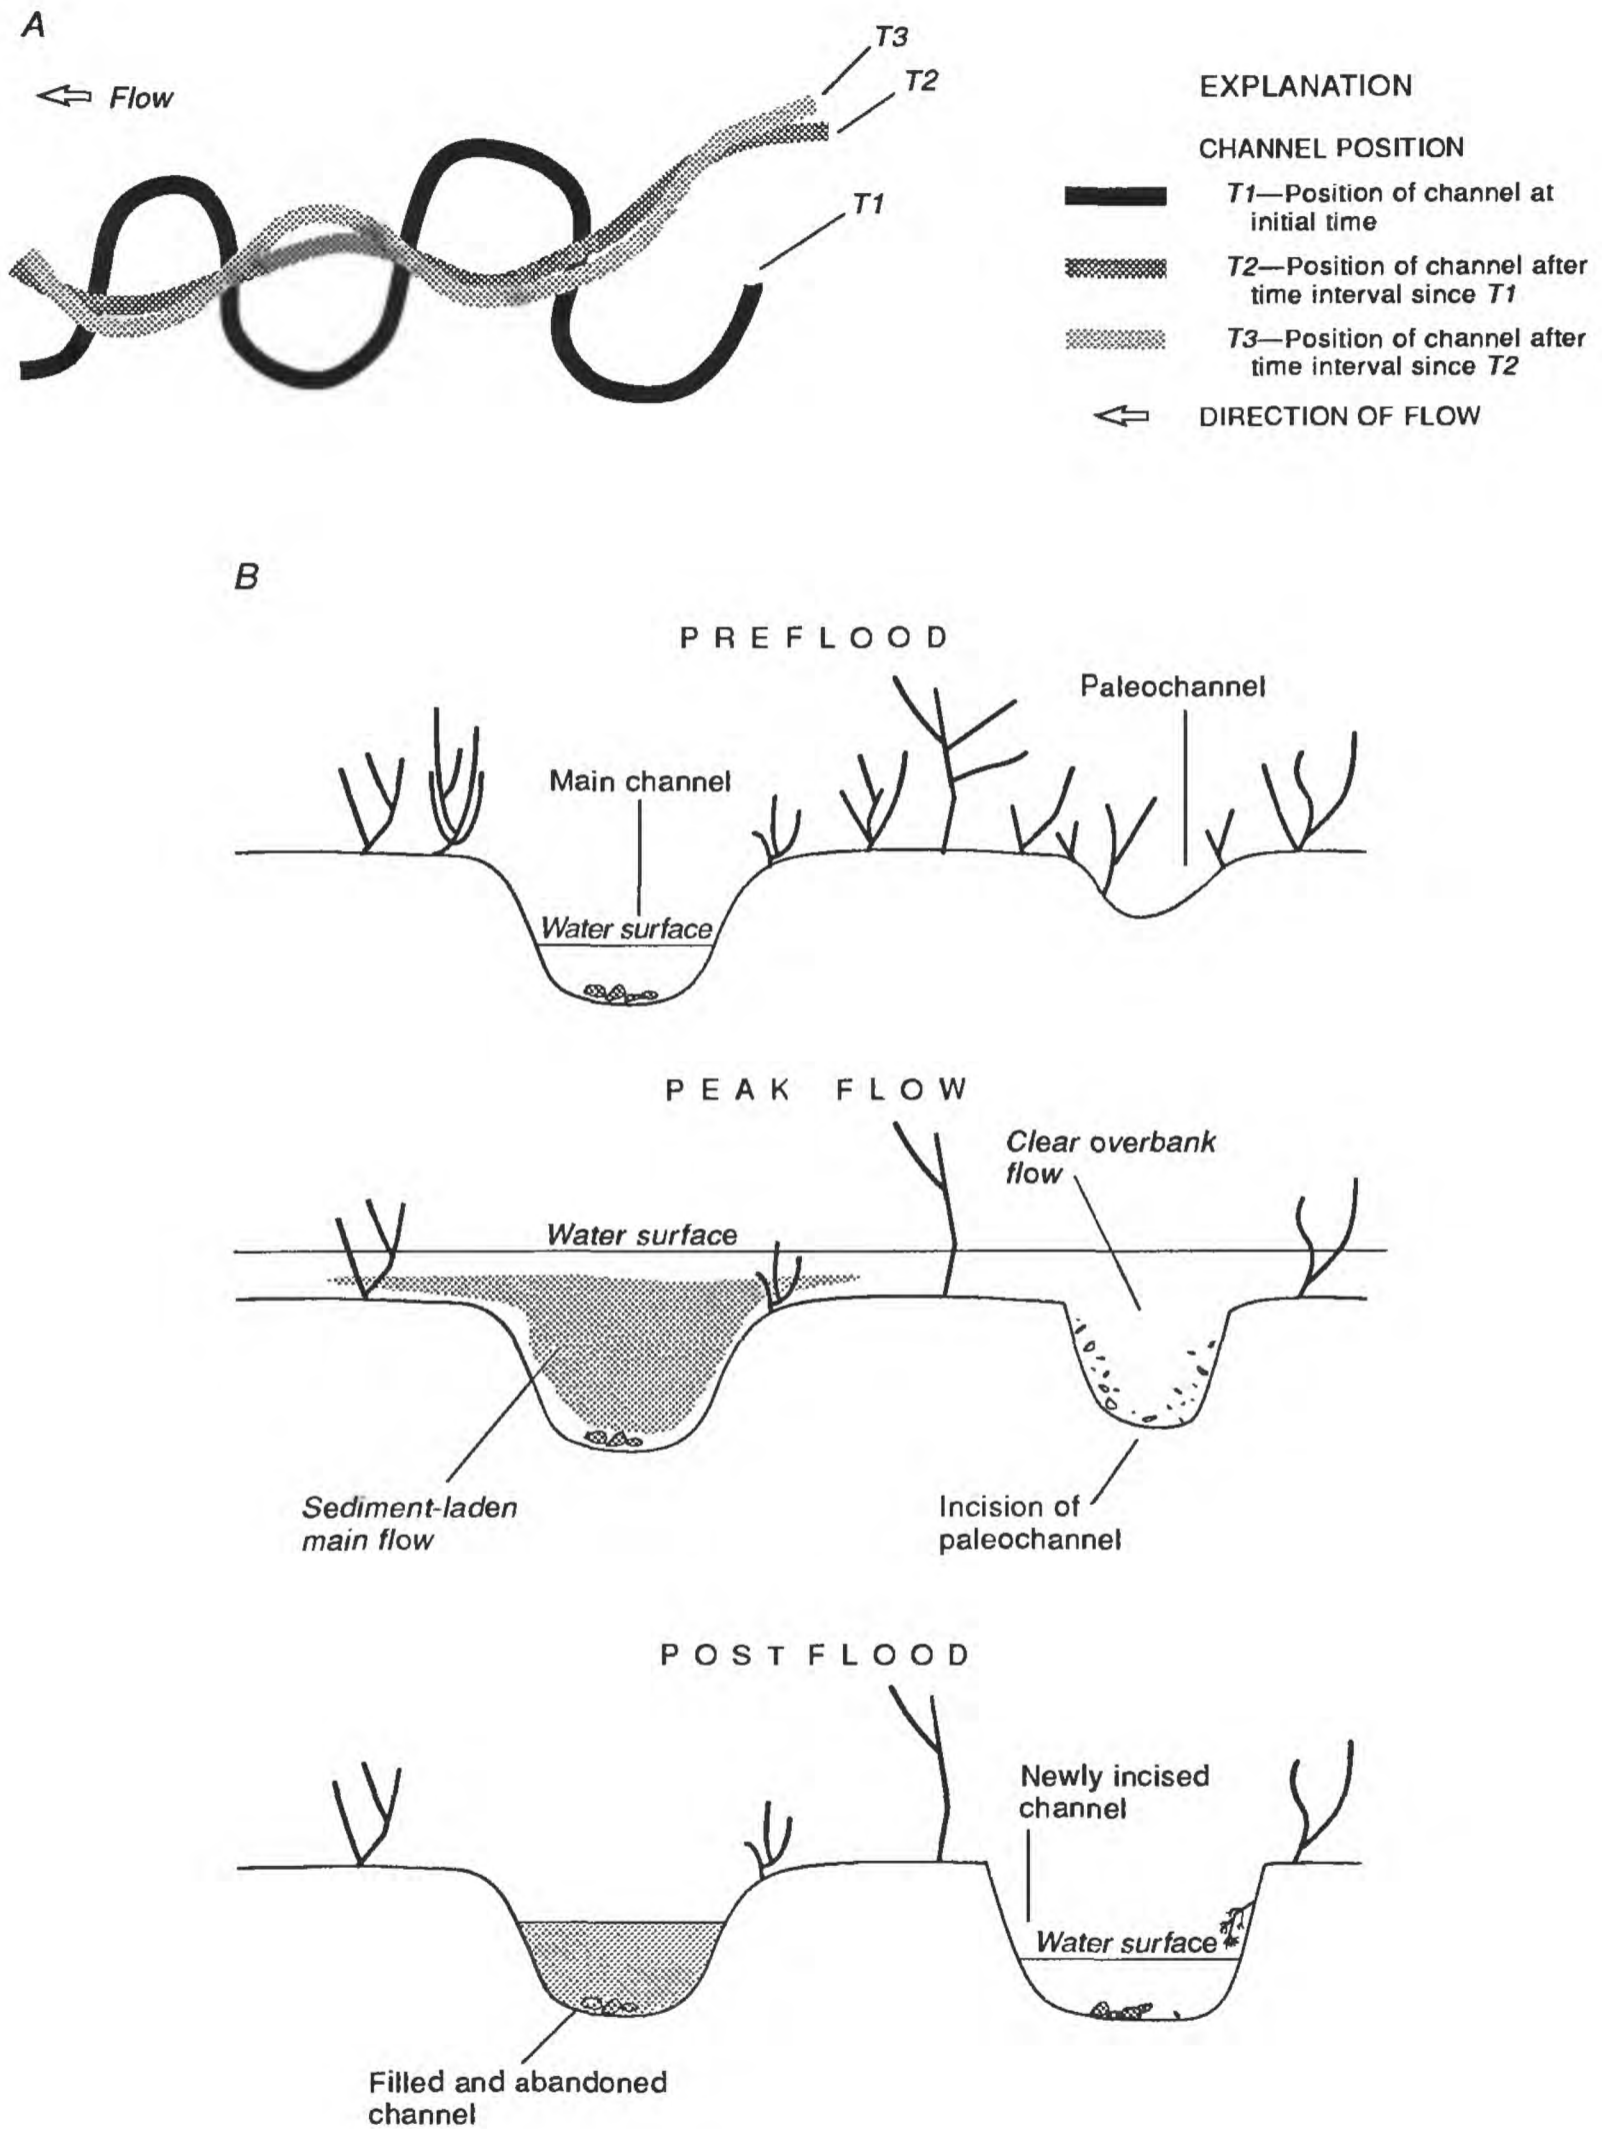
Figure 7. Avulsion and meander cutoff. *A*, Plan view of an initially sinuous channel at time 1 (*T1*) that changes course as a result of a flood (*T2*) and then is modified by subsequent meander migration during low flows (*T3*). *B*, Processes that produce a lateral shift in channel position by avulsion or meander cutoff.

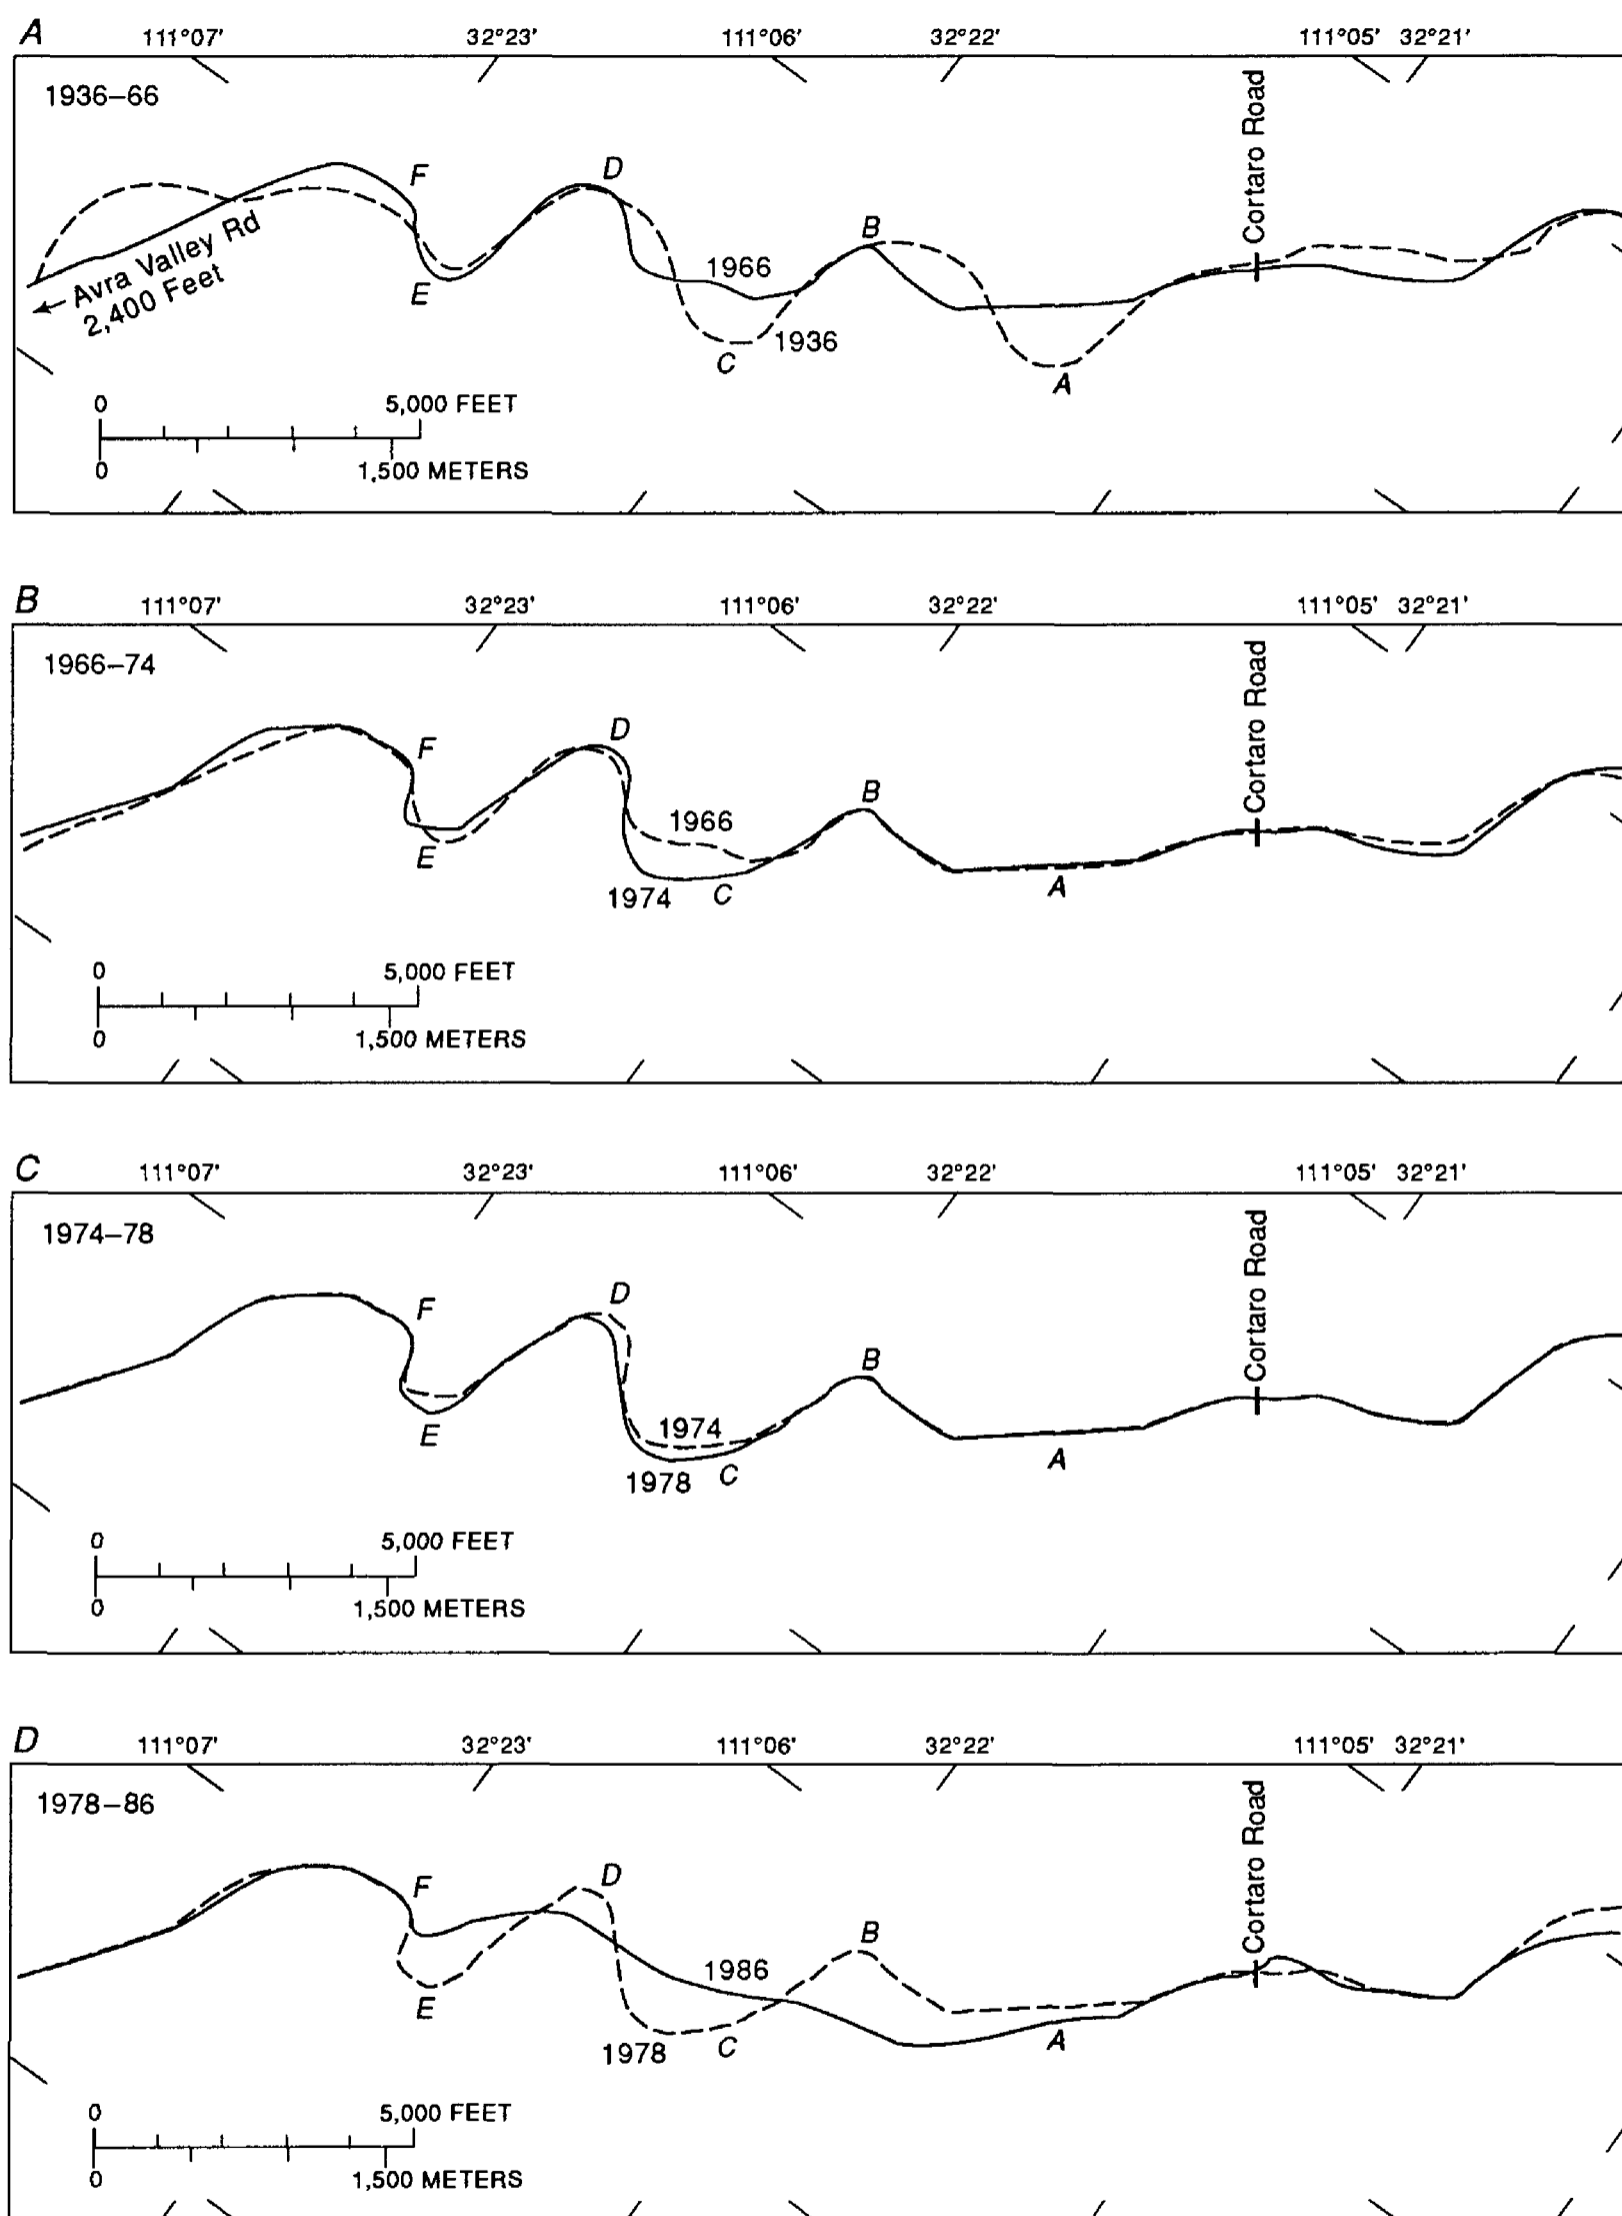
Figure 8. Meander development on lower Cortaro reach. Lines show location of channel center line.

Between 1936 and 1966, the lower Cortaro reach showed a high degree of channel instability (fig. 9) caused by meander migration (meanders B, D, E, and F, fig. 8) and meander cutoff (meanders A and C). The position of the channel center line shifted laterally as much as 900 ft because of cutoff at meander A.

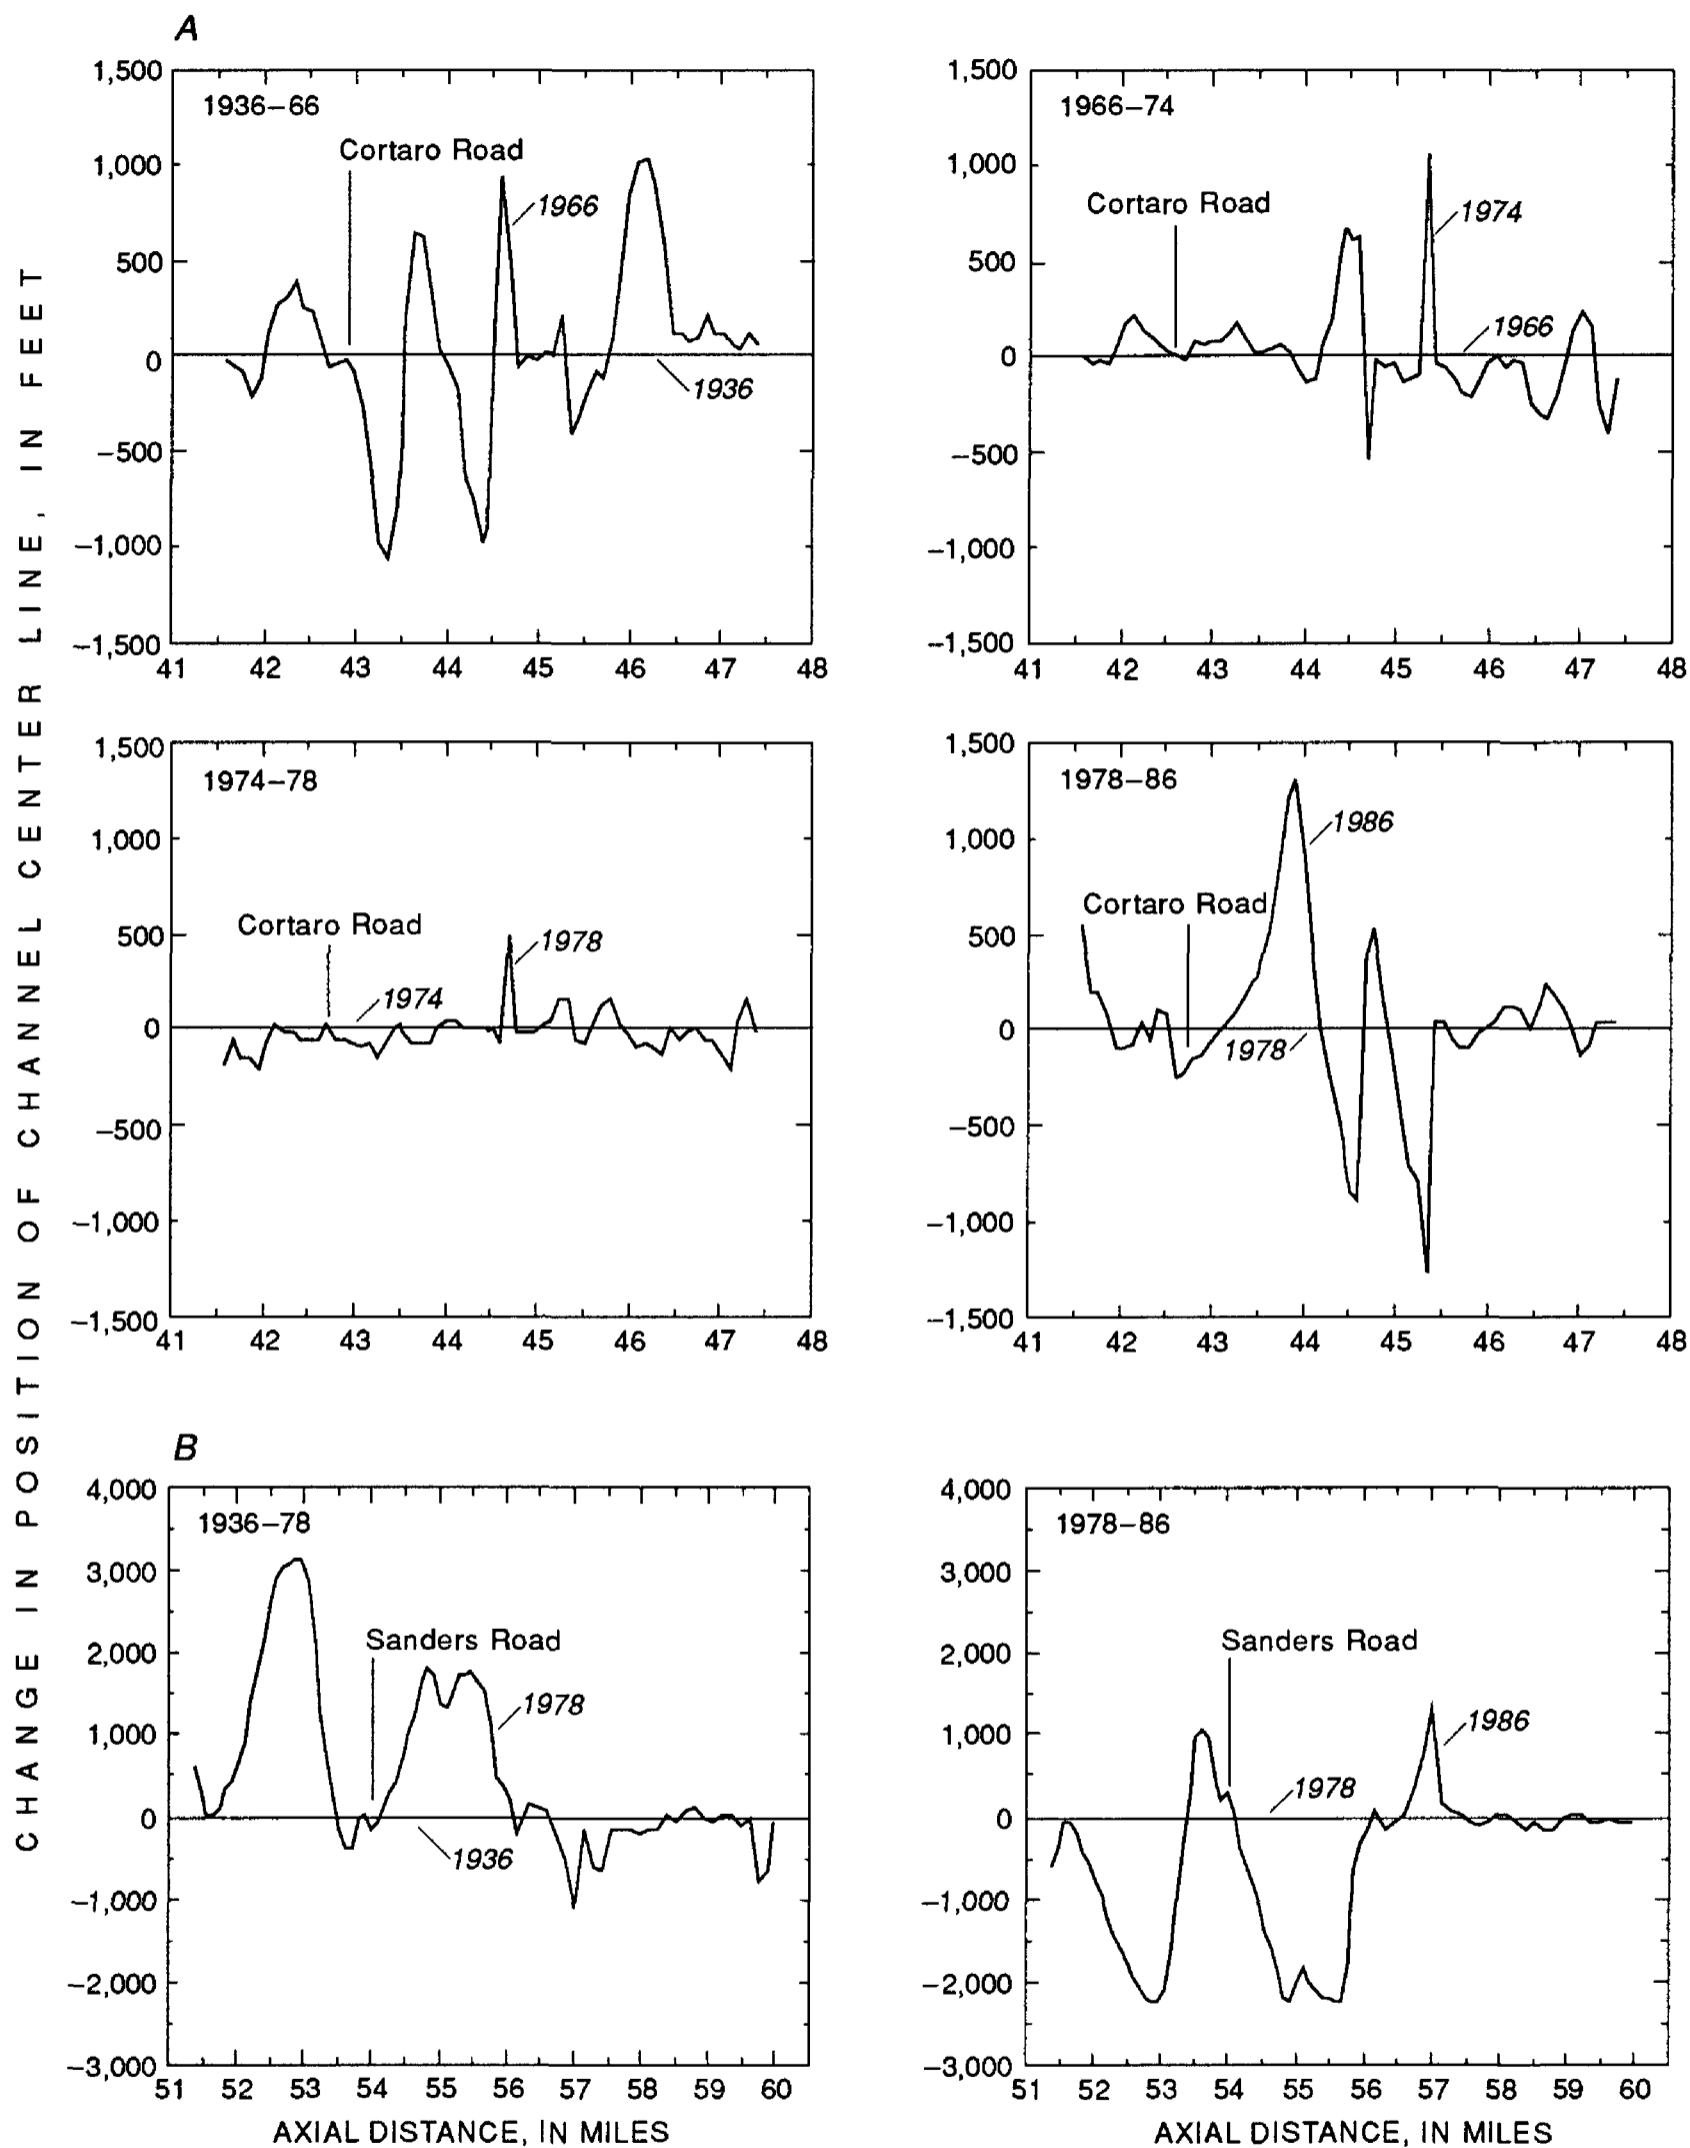
Figure 9. Changes in position of channel center line. A, Lower Cortaro reach. B, Upper Marana reach. Positive values indicate shift in position toward left side of channel; negative values indicate shift toward right side.

Between 1978 and 1986, all meanders between Cortaro and Avra Valley Roads except one were destroyed during the flood of 1983, which had a peak discharge of 65,000 ft³/s through the reach. On the Cortaro and Marana reaches, almost 23,000 ft of channel was abandoned 6 ft above the new channel bed, and channel position shifted laterally as much as 2,000 ft (fig. 9).

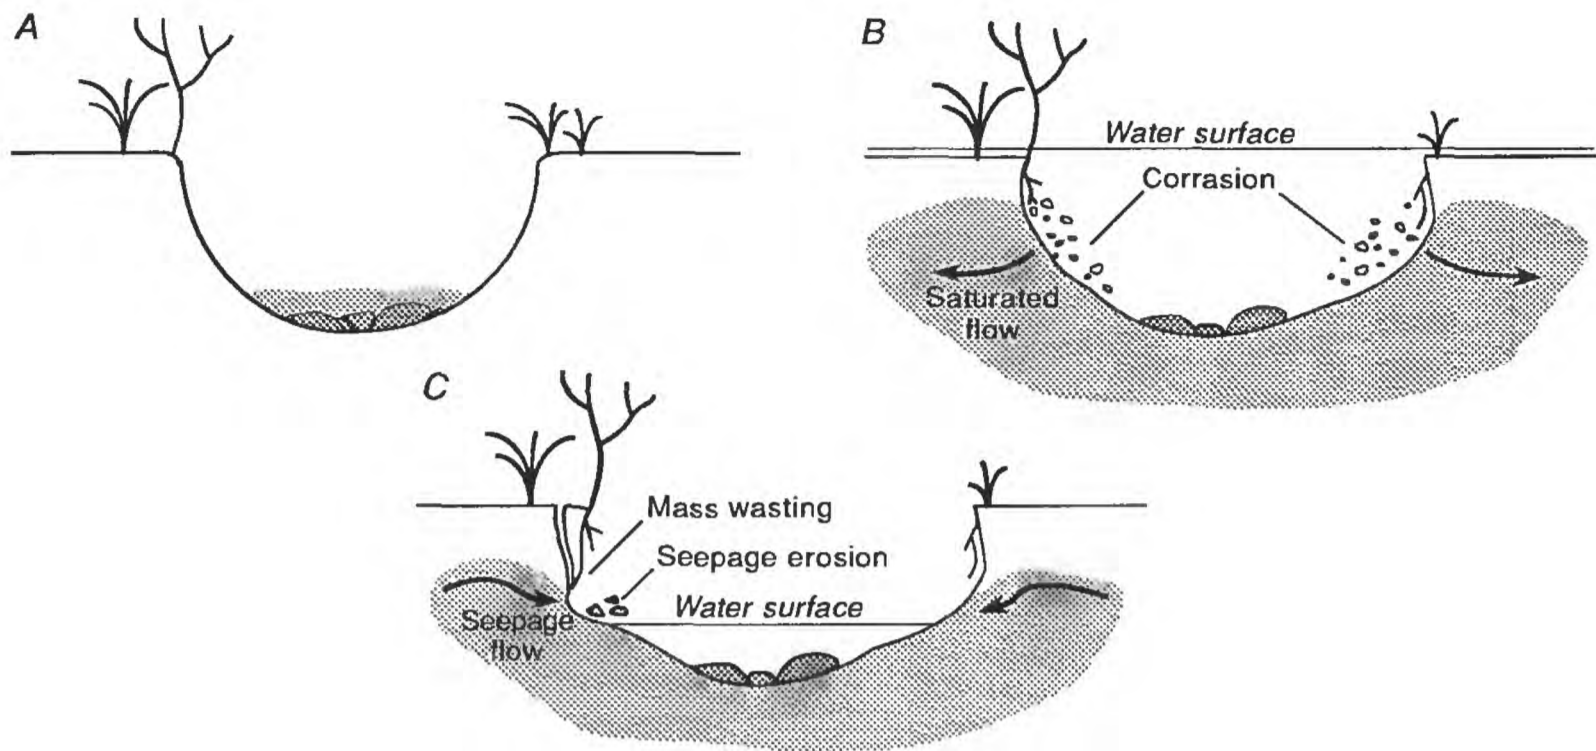
Figure 10. Process of channel widening. *A*, Initial channel. *B*, Corrasion and saturation of banks during rising flow. *C*, Seepage erosion and mass wasting following hydrograph fall.

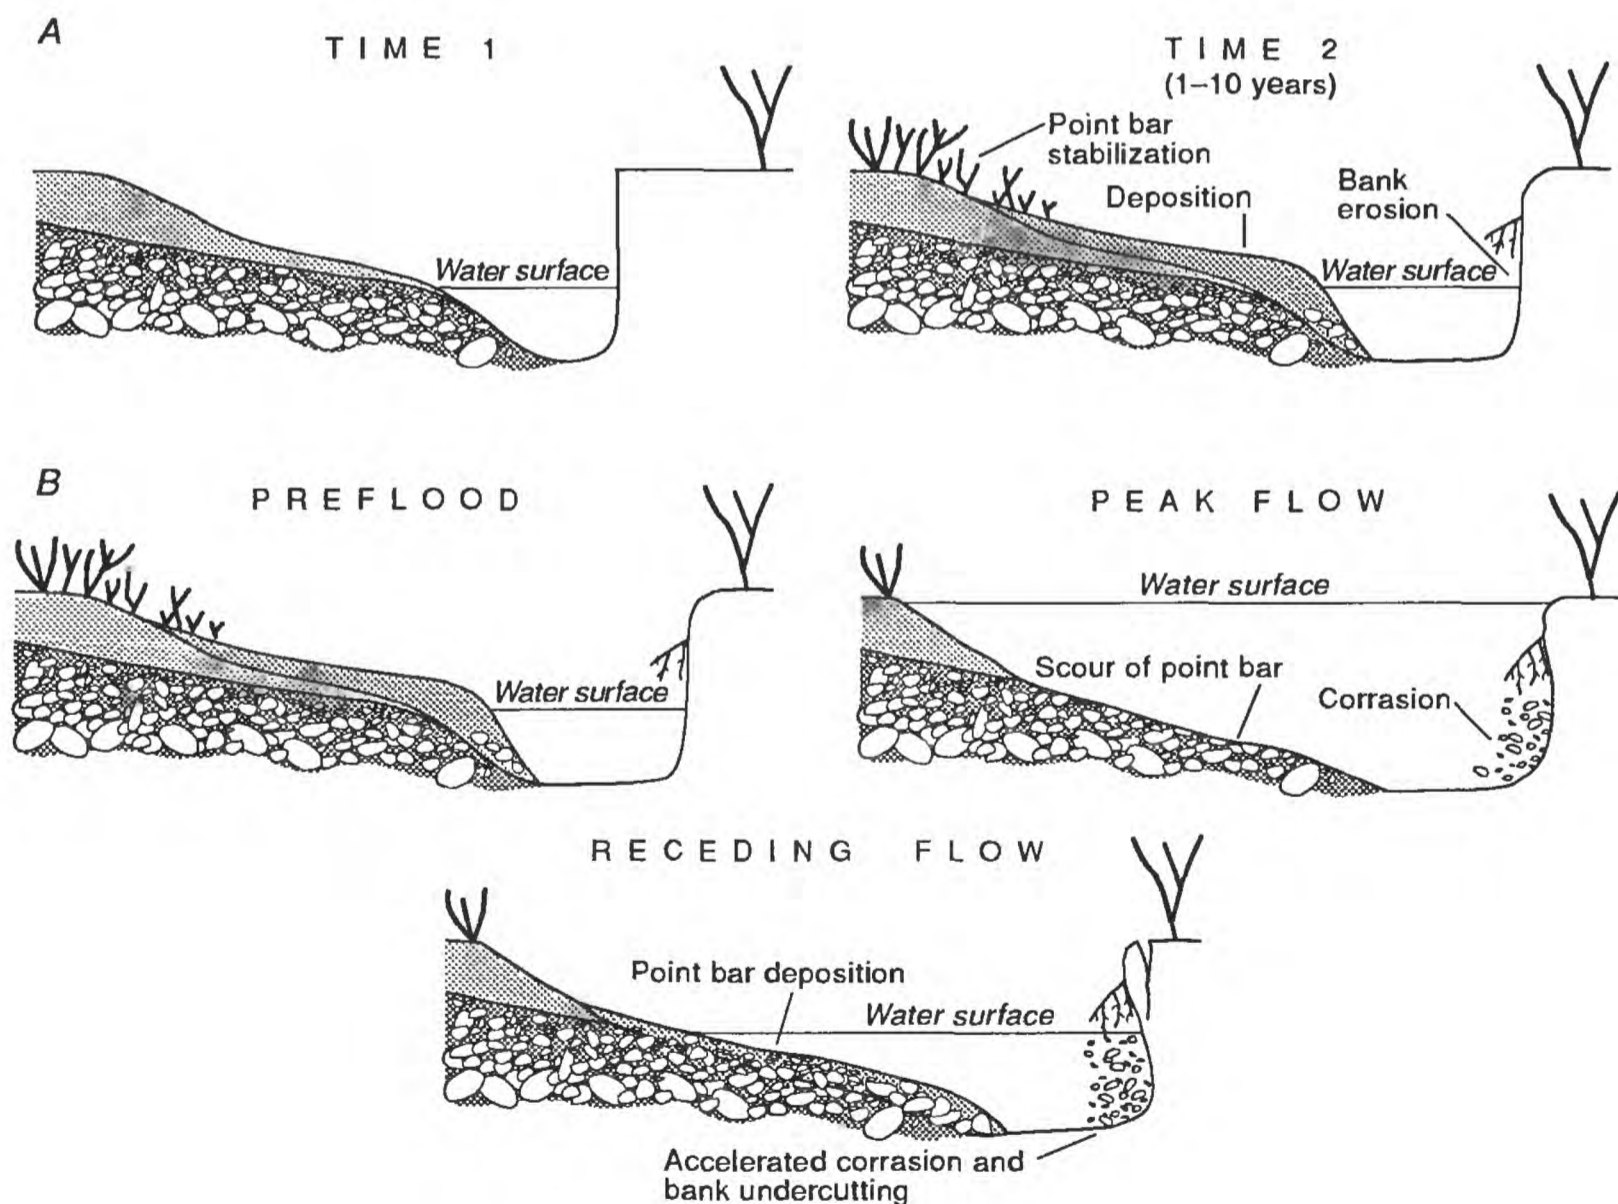
Figure 11. Role of channel migration in channel or arroyo widening. *A*, Migration in response to low to moderate flows producing no significant change in width. *B*, Migration in response to high flows producing channel widening.
